Hotel Guest Room RCU Arm Board Installation

Precautions

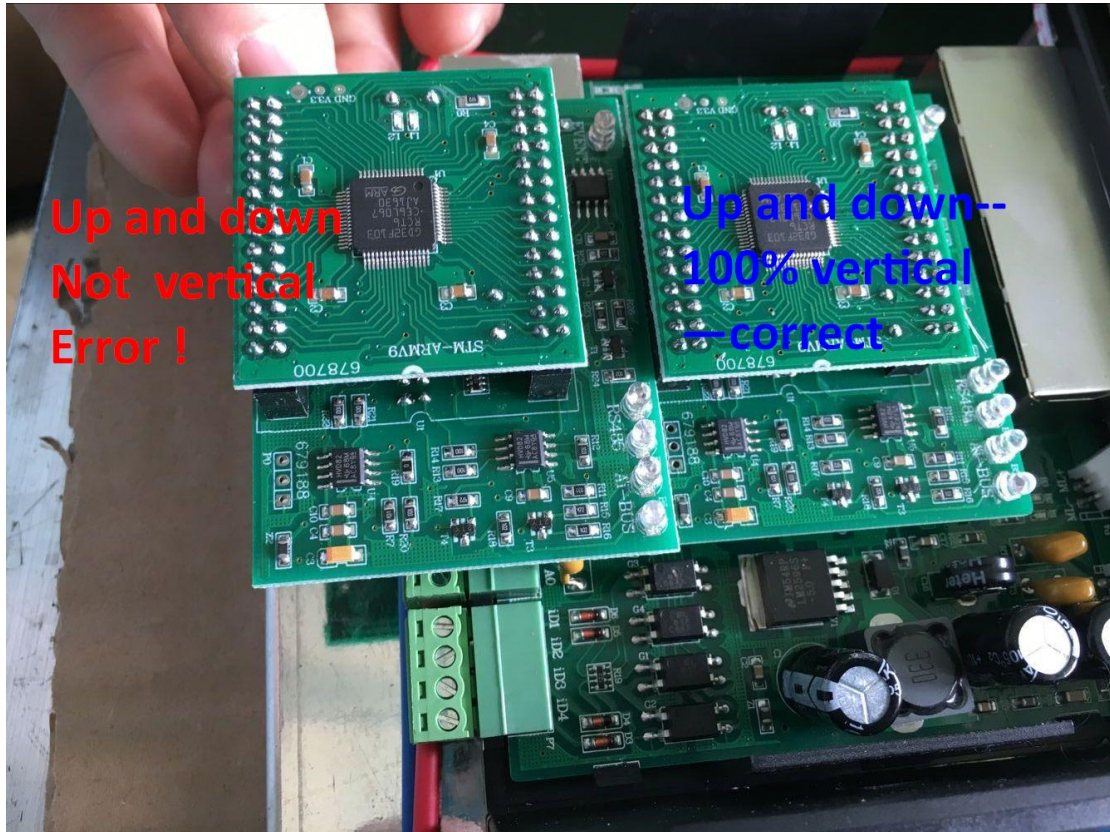
Up and down-Not vertical (top board insert has not match)-error!

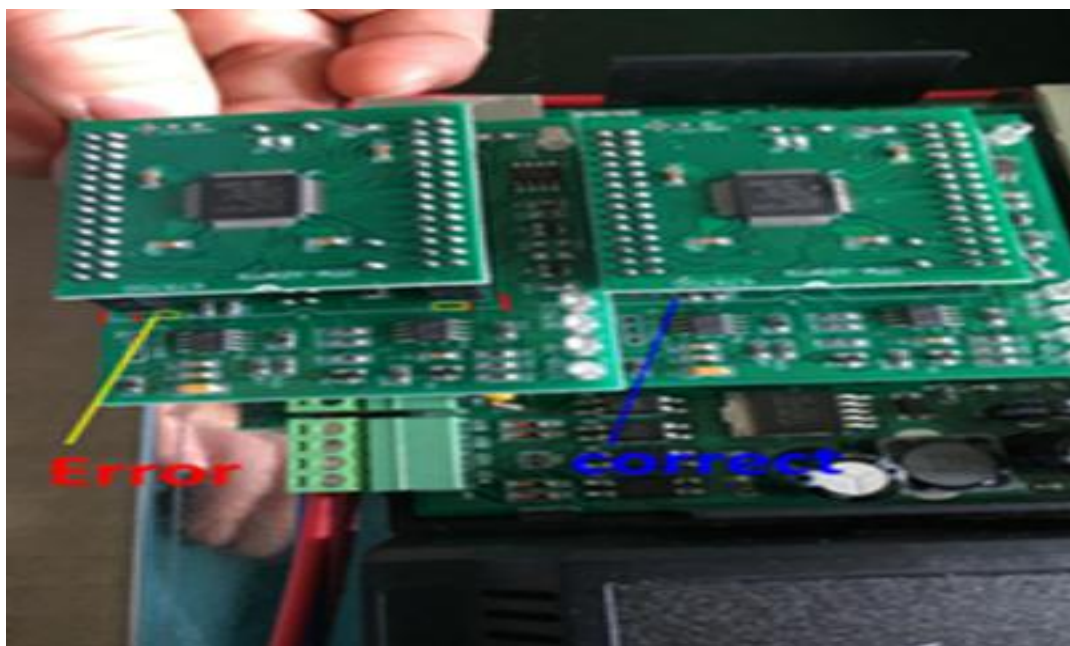
Up and down-100% vertical-correct

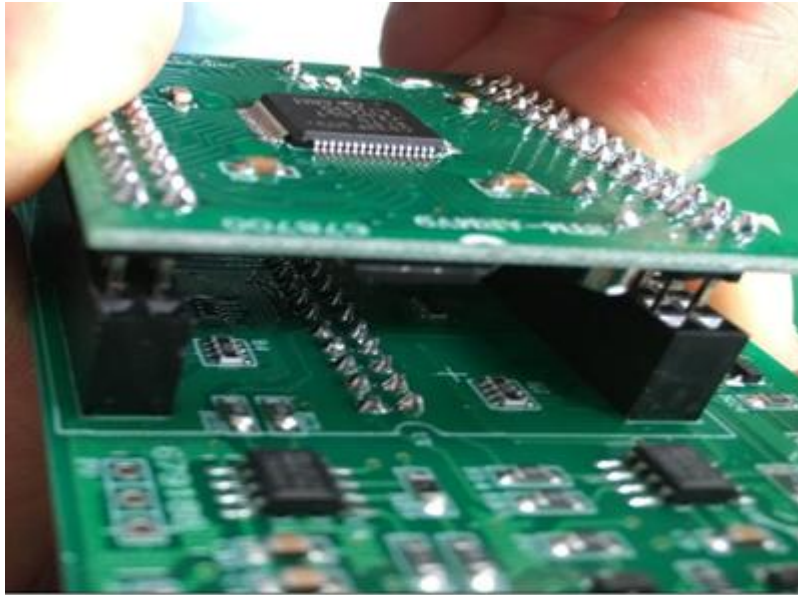
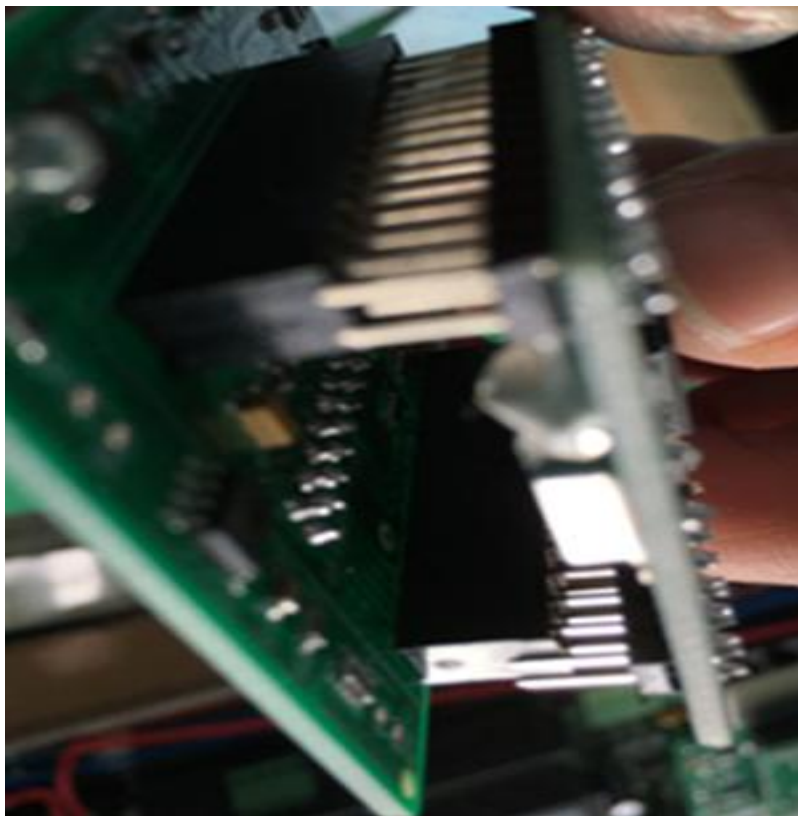
Error-Up and down-Not vertical (not match 100%)-error

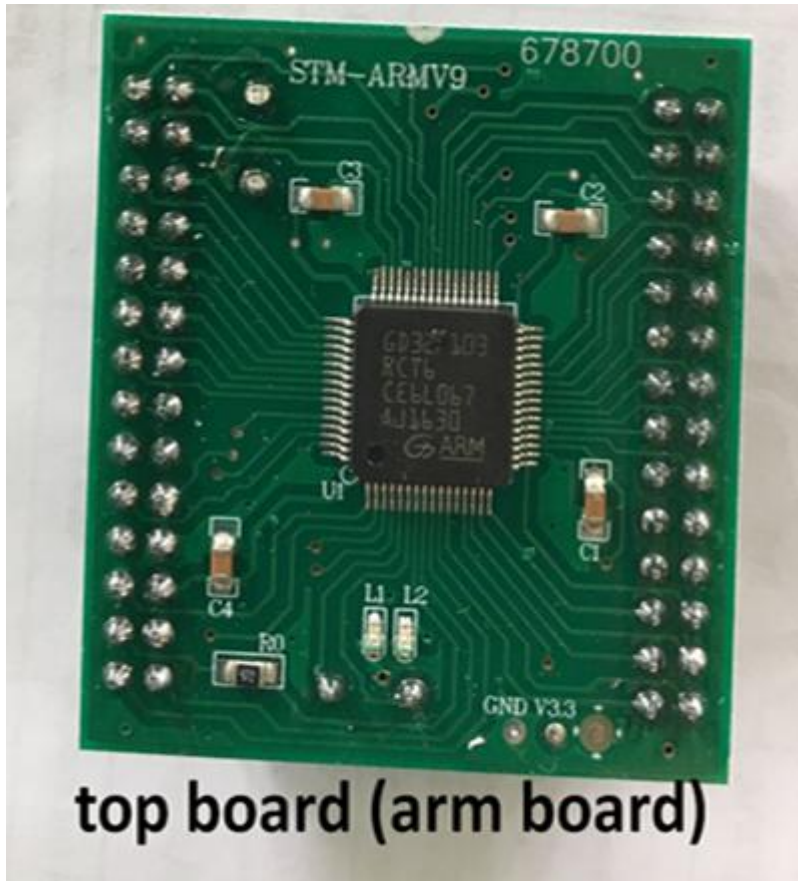
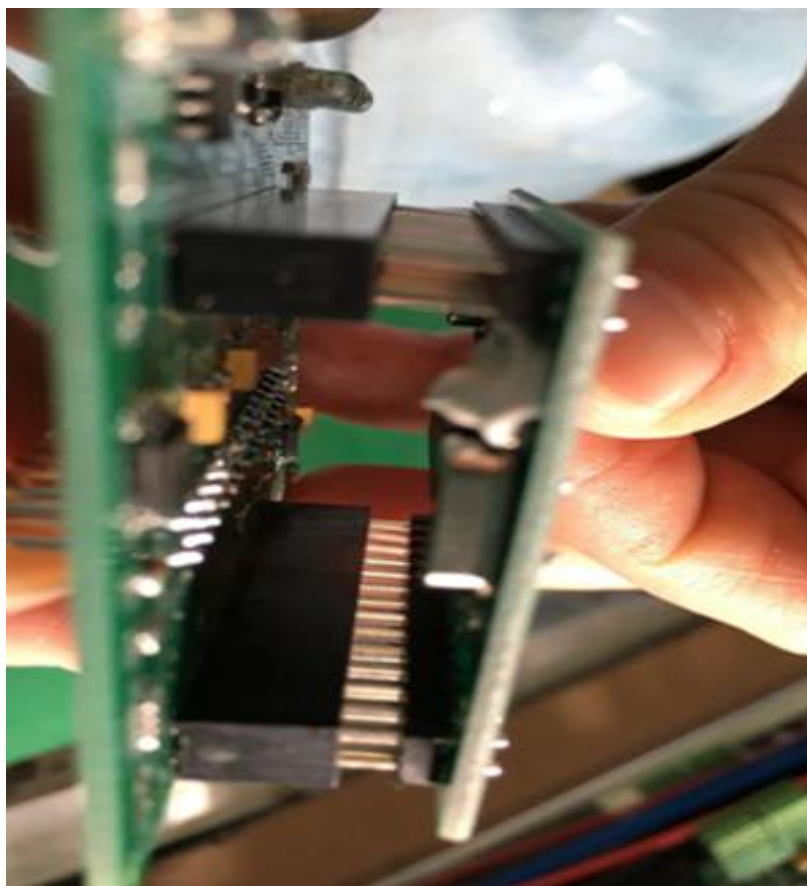
Correct Insert Method:
